Example Report

Your Reference	MC_28920/1275
Your Check Was Conducted On	26/06/2020
RAC Engineer	A MASTERS
Place of Inspection	EN13BD
Weather During Inspection	Sunny
Light Conditions	Good

Registration No	LN68RAC
Make	TOYOTA
Model	PRIUS ACTIVE VVT-I CVT
Year of Registration	2017
VIN	JTDKB3FU503554567
Engine No	Obscured
Engine Capacity	1798
Mileage	68847
Colour	WHITE
Hoist/Ramp Available	No
Condition Alert	No
MOT Expiry Date	Not present during inspection
Registration Docs Seen	No

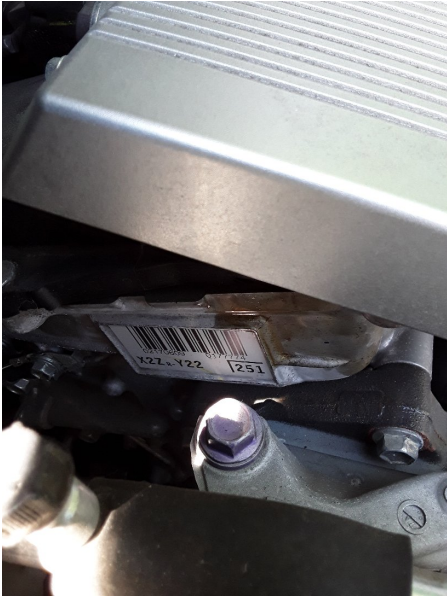
Essential: Engine Compartment > Engine Oil Leaks (External) > Upper Engine Area > Oil Residue

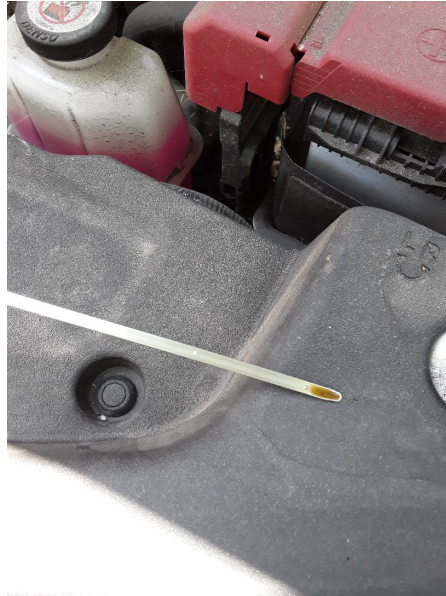
Essential: Engine Compartment > Engine Oil Level > Dipstick > Below minimum, top up recommended

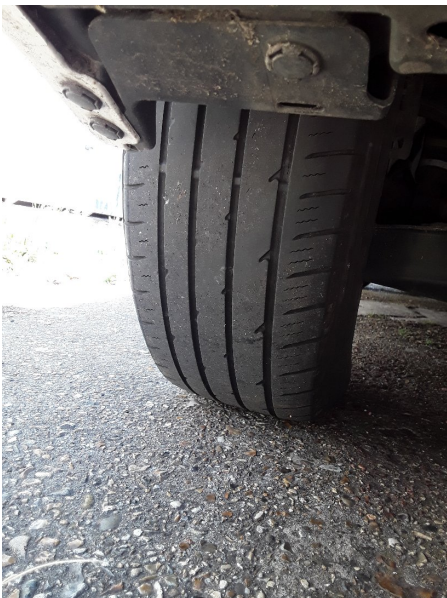
Uneven tyre wear, as noted within this report, may indicate incorrect steering geometry, resulting in excessive and rapid tyre wear. Therefore a full steering alignment and geometry check is recommended.

Essential: Wheels and Tyres > Tyre Rear Left Hand > Tread > Uneven Tyre Wear

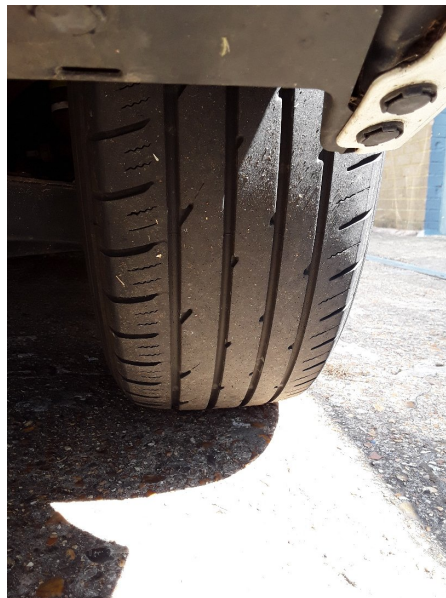
Essential: Wheels and Tyres > Tyre Rear Right Hand > Tread > Uneven Tyre Wear

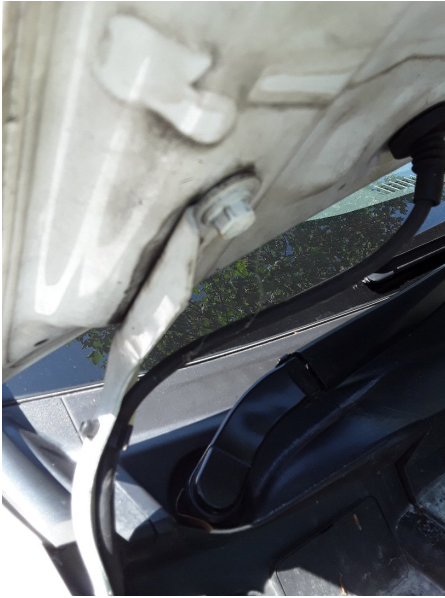
Measurement of the exterior paint thickness using a digital meter indicated that the vehicle had previously undergone some accident repairs. Readings obtained indicated that the left front wing had been replaced along with the bonnet and front bumper having been refinished. These findings were supported with evidence of paint witness marks observed to the bonnet hinge securing bolts indicating its previous removal/refitting.

Desirable: Body Exterior > Panel Condition / Previous Repair > Bonnet > Witness marks observed to securing bolts

Where visible, the vehicle repairs identified appear to have been generally carried out to an acceptable standard, with a minor touch in of the bonnet hinge securing bolts being recommended.

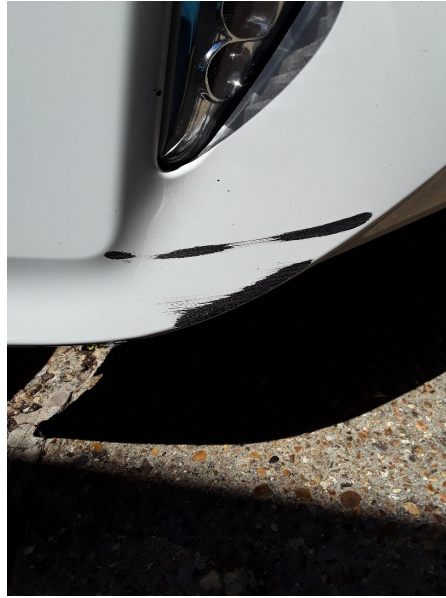
Desirable: Body Exterior > Bumpers > Bumper Front > Damaged

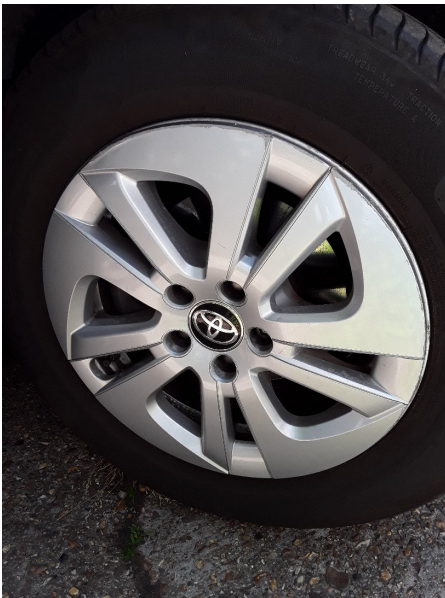
Desirable: Wheels and Tyres > Wheel Trim > Left Front Wheel Trim > Scuffed

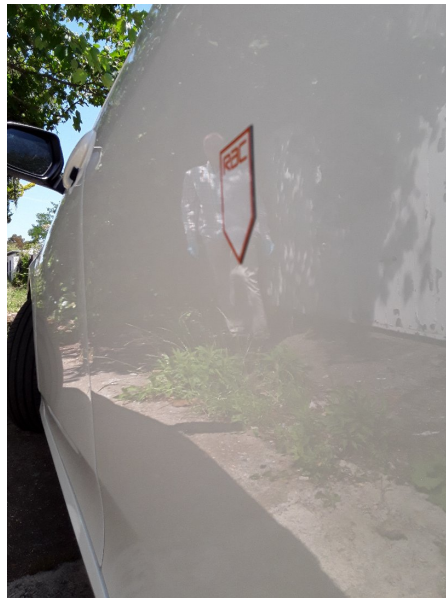
Desirable: Body Exterior > Panel Condition / Previous Repair > Door Rear Left > Dented

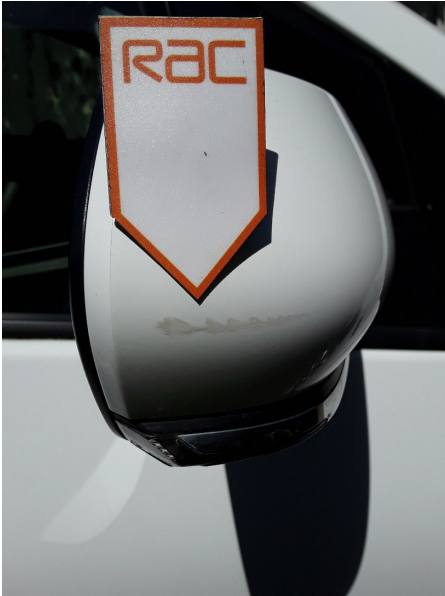
Desirable: Body Exterior > Exterior Trim > Mirror Casing Right > Scuffed

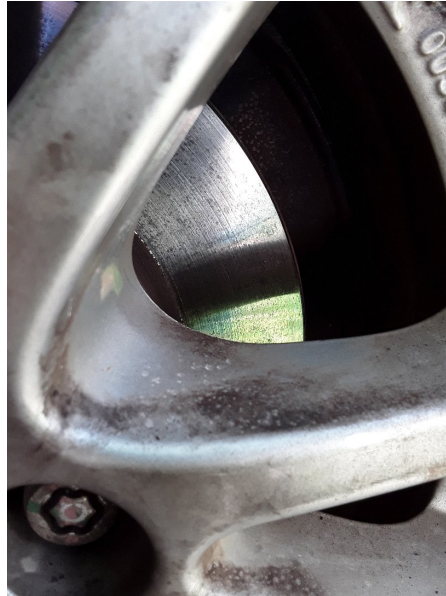
Desirable: Brake System > Discs / Pads / Linings > Left Front Brake Disc > Wear ridge evident

It is advised that the road wheels be removed and a general brake wear and serviceability inspection be carried out prior to purchase, to ensure that all components are within manufacturers' specified wear limit. The engine and inverter cooling systems antifreeze strengths were tested and found to offer protection down to -33 degrees C. The air conditioning output was measured using a digital thermometer and was found to drop to 4 degrees C.
