Example Report

Your Reference	MC_28919/1273
Your Check Was Conducted On	24/06/2020
RAC Engineer	A MASTERS
Place of Inspection	HA11HS
Weather During Inspection	Dry
Light Conditions	Good

Registration No	LM04RAC
Make	PEUGEOT
Model	307 S
Year of Registration	2003
VIN	VF33CNFUB83077849
Engine No	Obscured
Engine Capacity	1587
Mileage	60140
Colour	BLUE
Hoist/Ramp Available	No
Condition Alert	No
MOT Expiry Date	Not present during inspection
Registration Docs Seen	No

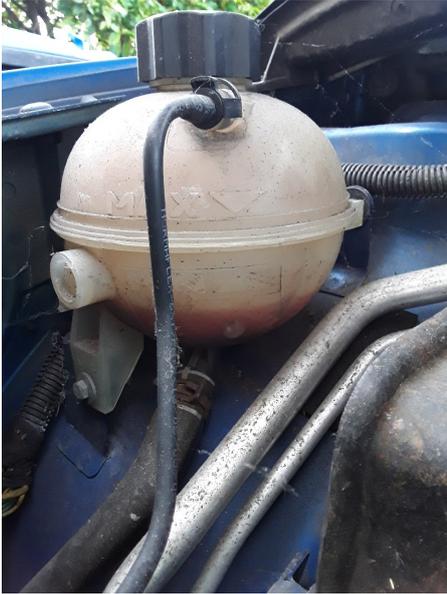
The Engineer noted low engine coolant content. This should be replenished in accordance with the manufacturers' recommendations and the system rechecked for leakage / coolant loss.

Essential: Engine Compartment > Coolant Level > Coolant Content > Below Minimum, top up system, replenish lost antifreeze and pressure to identify possible leaks

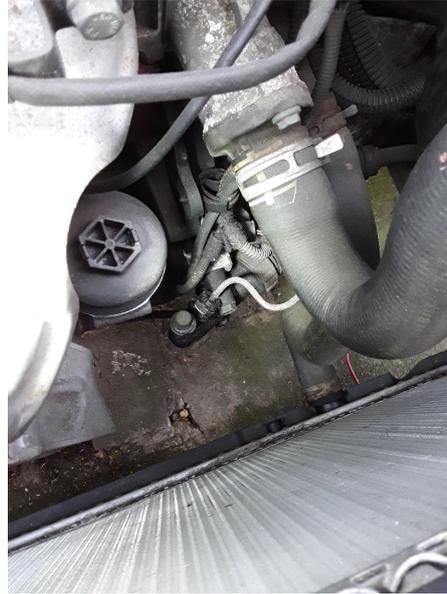
Essential: Transmission > Hydraulic System > Clutch Slave Cylinder > Evidence of Fluid Leaks, clean and investigate cause

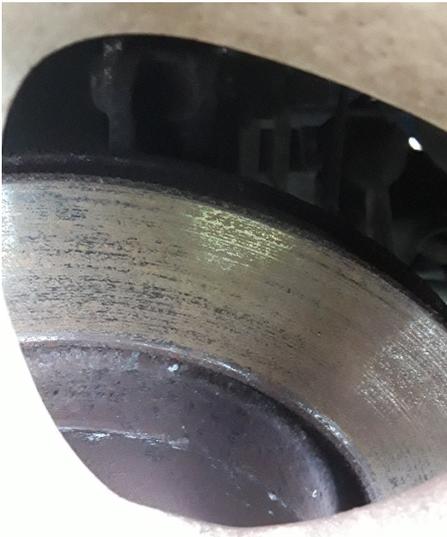
Essential: Brake System > Discs / Pads / Linings > Both Front Brake Discs > Corroded

It is advised that the road wheels be removed and a general brake wear and serviceability inspection be carried out prior to purchase, to ensure that all components are within manufacturers' specified wear limit.

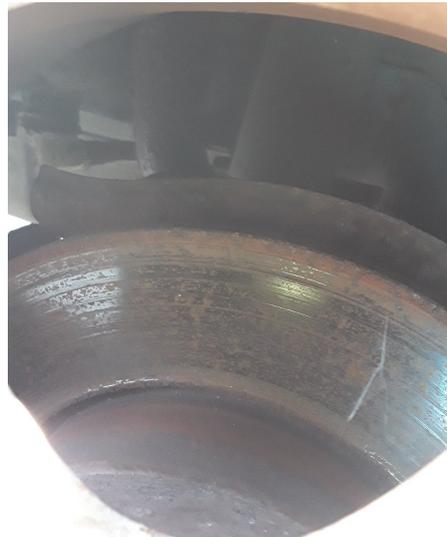
Essential: Brake System > Discs / Pads / Linings > Both Rear Brake Discs > Corroded and ridged

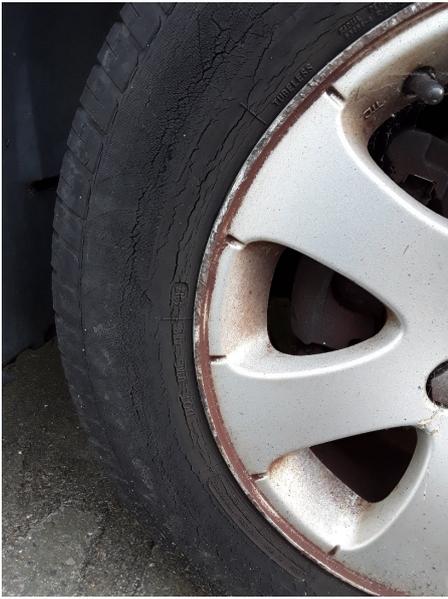
Essential: Wheels and Tyres > Tyre Front Left Hand > Sidewall > Cracked

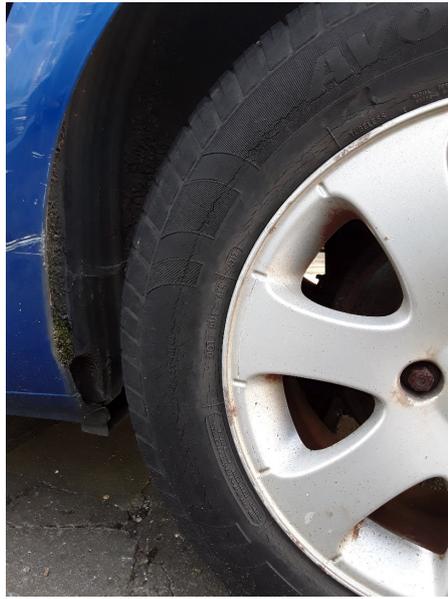
Essential: Wheels and Tyres > Tyre Rear Left Hand > Sidewall > Cracked

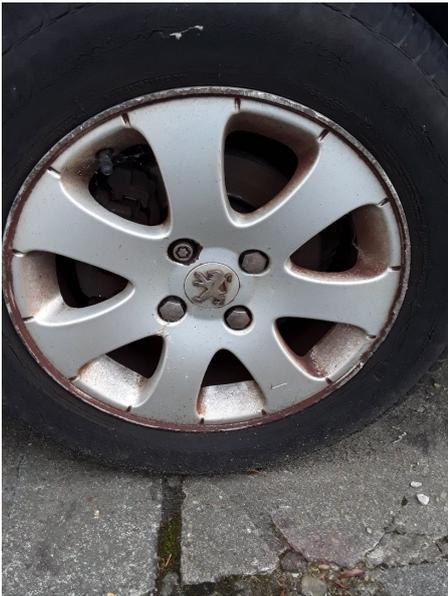
Desirable: Wheels and Tyres > Wheel / Rim > Left Front Wheel > Damaged

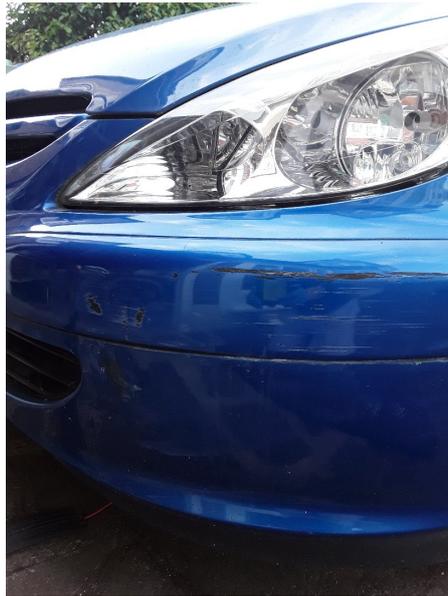
Desirable: Body Exterior > Bumpers > Bumper Front > Scratched

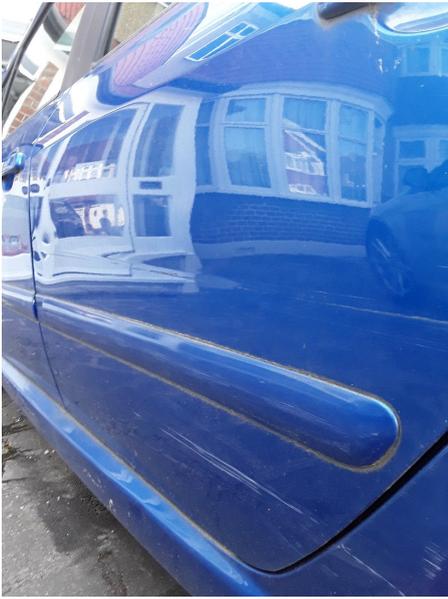
Desirable: Body Exterior > Panel Condition / Previous Repair > Door Rear Left > Dented and scratched

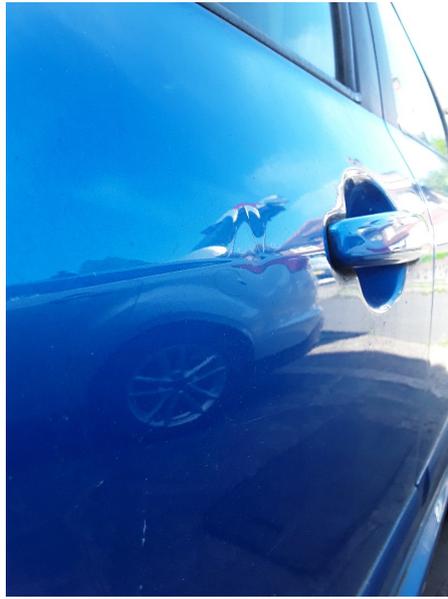
Desirable: Body Exterior > Panel Condition / Previous Repair > Door Front Left > Dented

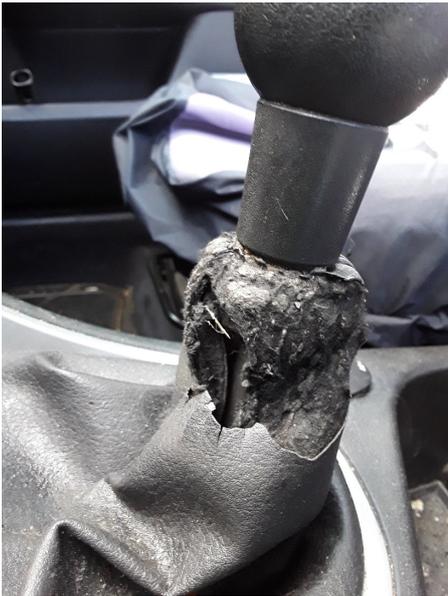
Desirable: Interior / Luggage Compartment > Dash Panel (Condition) > Gear Lever Gaiter > Perished and split

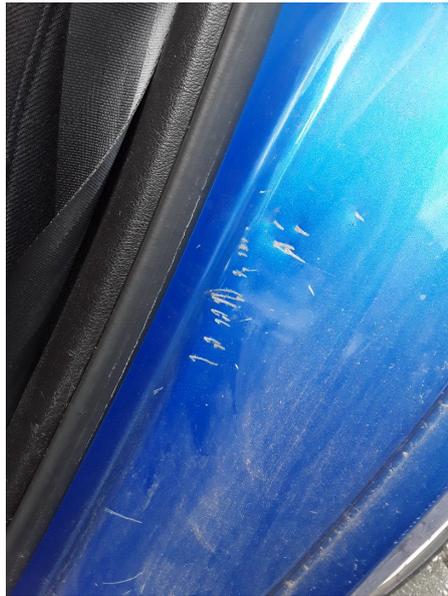
Desirable: Interior / Luggage Compartment > Interior Sills / Shut Area > Left Rear Interior Sill / Shut > Dents and corrosion evident, recommend remedial attention to prevent further deterioration

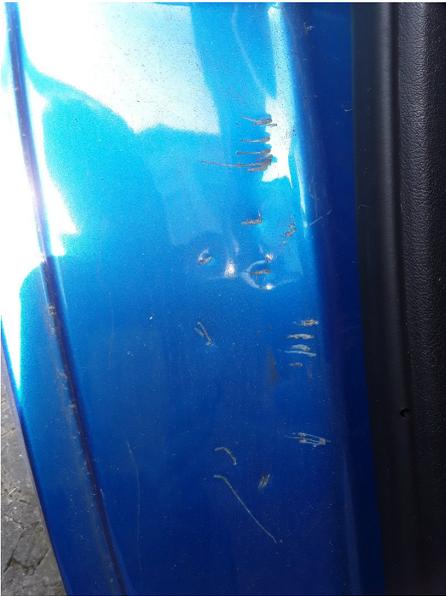
Desirable: Interior / Luggage Compartment > Interior Sills / Shut Area > Right Rear Interior Sill / Shut > Dents and corrosion evident, recommend remedial attention to prevent further deterioration

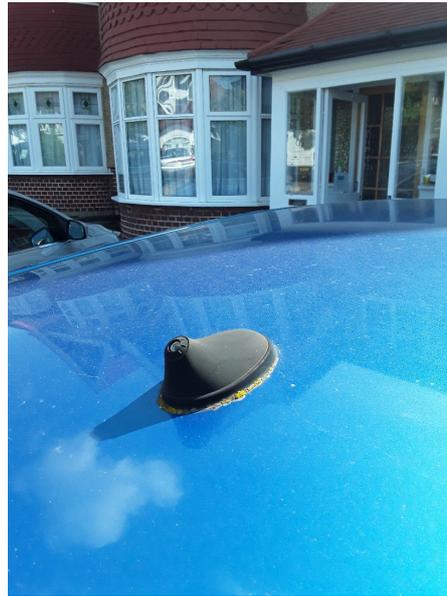
Desirable: Electrical / Controls > In Car Entertainment Systems > Aerial / Antenna > Missing

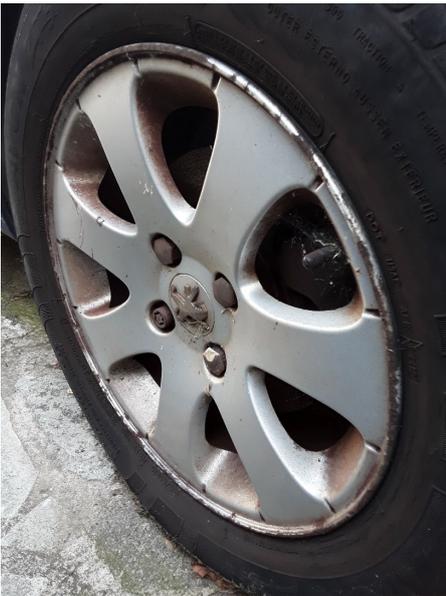
Desirable: Wheels and Tyres > Wheel / Rim > Right Front Wheel > Scuffed
